INSPECTOR GENERAL

AUGUST 13, 2015

Continental United States Military Housing Inspections— National Capital Region

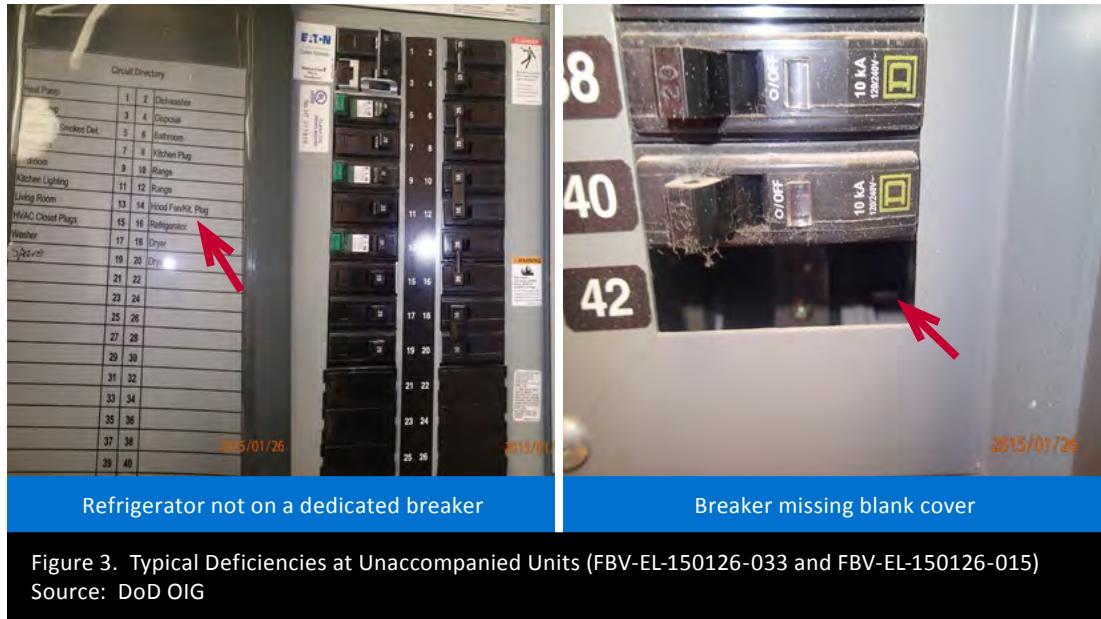
In the unaccompanied housing, we identified improper installation of dedicated breakers for refrigerators, inadequate installation of electrical receptacles and boxes, ceiling fans attached to unapproved electrical boxes, and missing breaker blanks in electrical panels. For instance, the use of an undedicated branch circuit for the refrigerator could cause unnecessary tripping of the circuit breaker resulting in food spoilage. Also, an uncovered opening in the breaker panel could lead to unwanted debris entering electrical panel and creating a short circuit. Figure 3 shows typical examples of the deficiencies found.

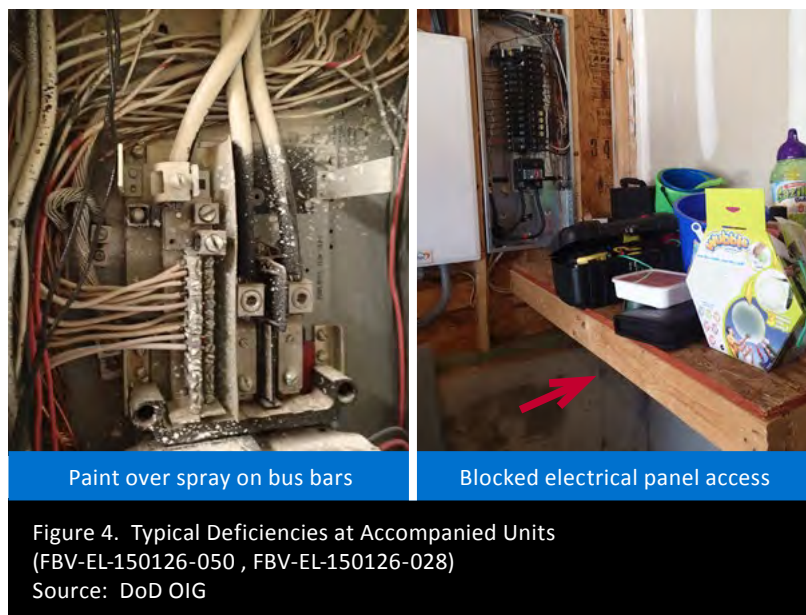
In the accompanied housing, we identified non-ground fault circuit interrupter (GFCI) protected electrical outlets, improper installation of electrical panels, paint over spray on the inside of electrical panels, and inaccessible electrical panels. Household and/or vending GFCI examples included GFCI outlets not being used in the required locations such as laundry rooms. For instance, some electrical outlets were not GFCI; the requirement is to have GFCI protection within 6 feet of the outside edge of the sink to prevent the risk of shock or electrocution. Paint spray on bus bars can lead to overheating and increasing risk of fire, and inaccessible electrical panels prevent immediate access in an emergency. Figure 4 shows typical examples of the deficiencies the found during the inspection.

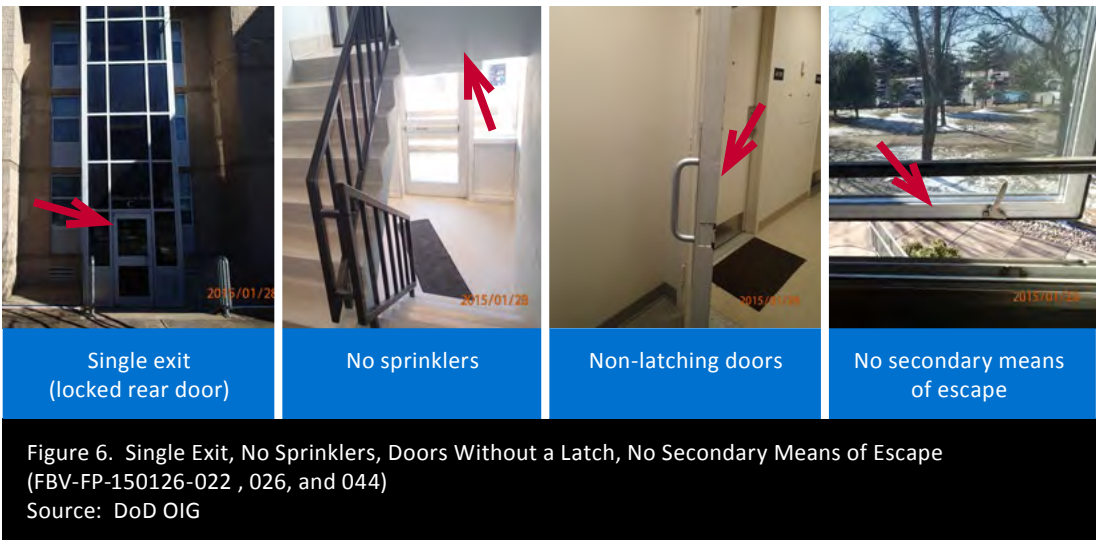
In unaccompanied housing the team identified deficiencies in the installation of sprinkler systems, windows that were undersized, sprinkler heads that were covered, fire extinguishers that were not periodically inspected or maintained, structural fire barriers that were defeated, insufficient exit signage, fire doors propped open, and a dryer vent needing immediate cleaning. For instance, at McRee barracks the sprinkler systems were not installed at the top and bottom of the exit stairs, which in the event of a fire could affect the structural integrity of the stairs or prevent the use of the stairs as a protected means of egress. McRee Barracks living quarters had windows that did not meet the minimum opening dimensions for a secondary means of escape for occupants. In several of the inspected barracks, sprinkler heads were covered with paint or protective caps used during shipping. If the sprinkler head bulb is painted or covered, it will not break at the right temperature and release water. The team found fire extinguishers that were not periodically inspected, nor showed any objective evidence of the required 6-year maintenance activities being performed. In McRee Barracks, the fire extinguishers were found in locked-cabinets equipped with unbreakable Plexiglas preventing accessibility in a fire emergency.

In addition, signage was deficient throughout USAG Fort Belvoir. Some exit signs were missing, not illuminated, were mounted inside the stairwells instead of the common corridors, and mounted too far away from the stairwell exit doors. Also, several doors were propped open, which could lead to smoke entering stairwells, thus preventing the use of a particular exit as a means of egress. We also found several instances of compromised fire barriers; due to cable conduits routed through unsealed holes in fire barrier walls in electrical and mechanical rooms creating a means for fire and smoke to propagate. Figure 6 shows examples of the deficiencies.

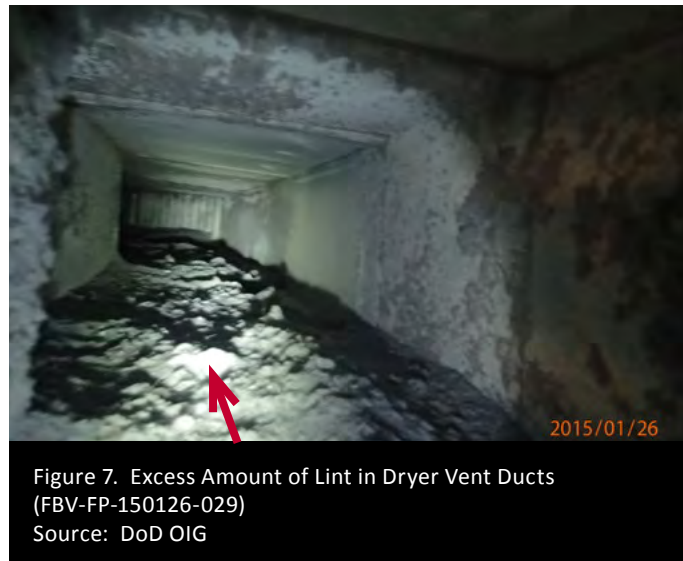
Although not a systemic item, a dryer vent had an excessive amount of lint build-up (see Figure 7). Dryer lint build up is a leading cause of household fires.

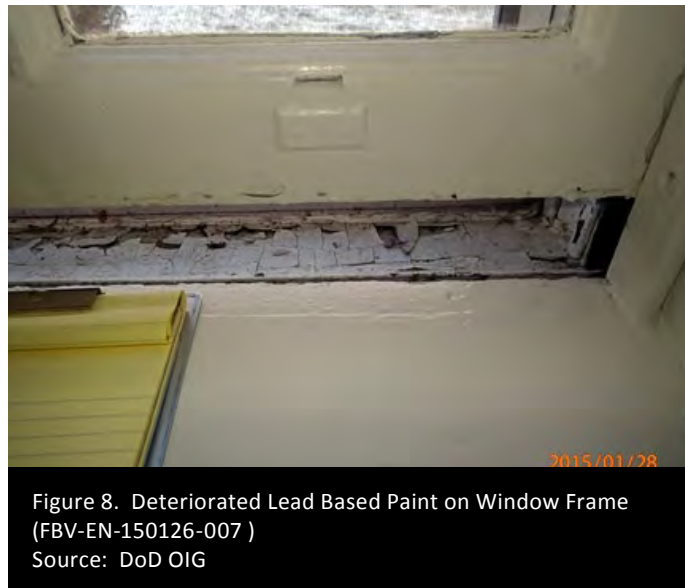
In accompanied housing, specifically at Fort Belvoir and Gerber Village houses, we noted the presence of deteriorated lead based paint on window components, exterior columns, and interior door surfaces. The Fort Belvoir Residential

Communities Operations and Maintenance (FBRC O&M) Plan states, “[l]ead Hazards exist when the lead based paint is defective (for example, flaking, peeling, or chalking).” In accordance with the FBRC O&M plan, lead based paint is present in housing built before 1978 housing at Belvoir, Gerber, Jadwin, and River Villages. Specifically, the FBRC O&M plan states that the white window trim “in all units in Belvoir Village should be assumed to have lead based paint.” The observed presence of lead based paint confirmed that lead hazards have not been corrected, as required by the FBRC O&M Plan (see Figure 8). Lead based paint increases the risk of occupant exposure to lead compounds.

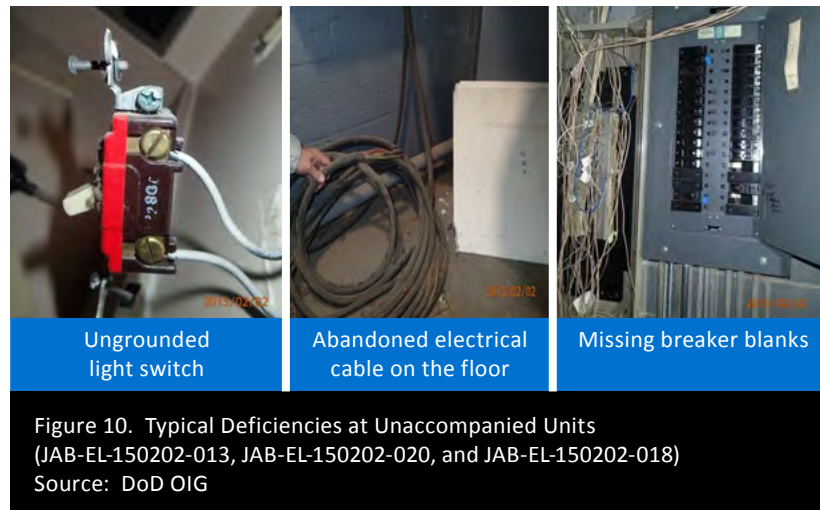
In unaccompanied housing, we found ungrounded light switches and electrical receptacles and an electrical panel cable that was unterminated, which could cause an electrical shock or short circuit. We also found missing breaker blanks that could lead to unwanted debris or pests entering through electrical panels, creating the possibility of arc flash and fire. Figure 10 shows typical examples of the deficiencies found.

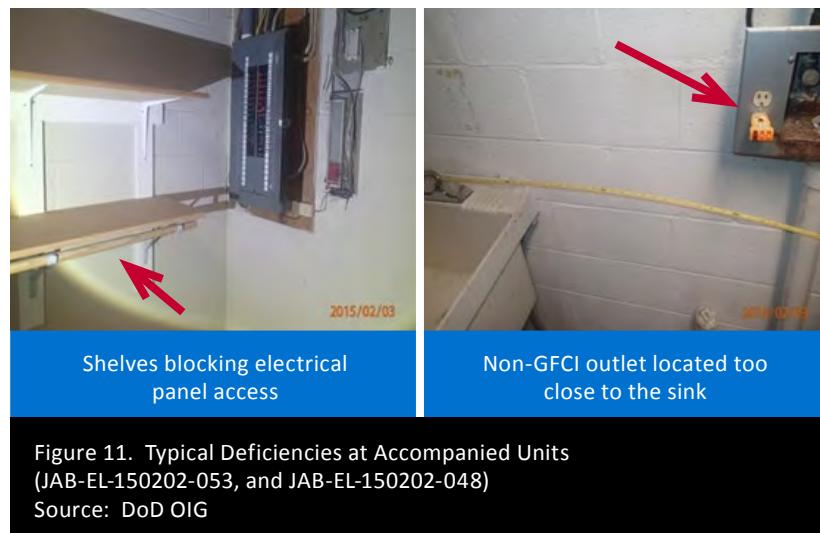
In accompanied housing, we identified inaccessible electrical panels, on-GFCI protected electrical outlets at required locations, and unsecured electrical wires. For instance, we found electrical junction boxes with missing covers and exposed energized wires increasing the risk of electrical shock. Figure 11 shows typical examples of the electrical systems deficiencies found.

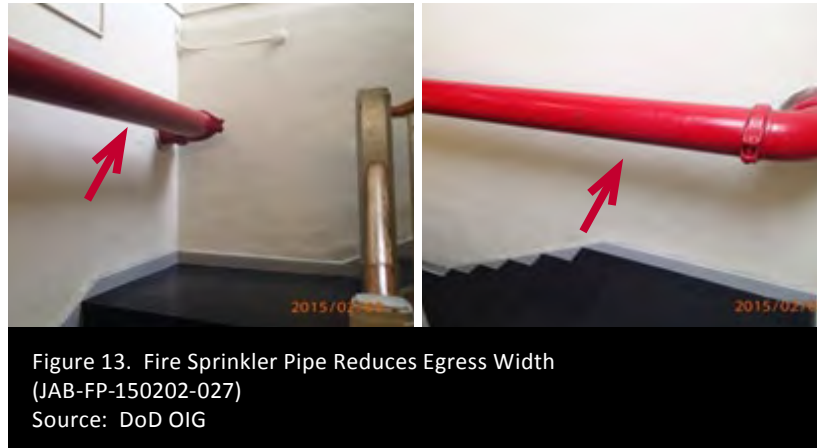
At JBAB, most deficiencies found in the unaccompanied housing were related to fire protection and suppression systems, and means of egress. In the Enterprise Hall, we found a large fire sprinkler pipe projected into the stairwell reducing egress width of stairwell below the required 36 inches (see Figure 13). The reduction in stairwell egress width by the sprinkler pipe is a code violation that can slow egress. Injury could also occur if somebody walks into the pipe.

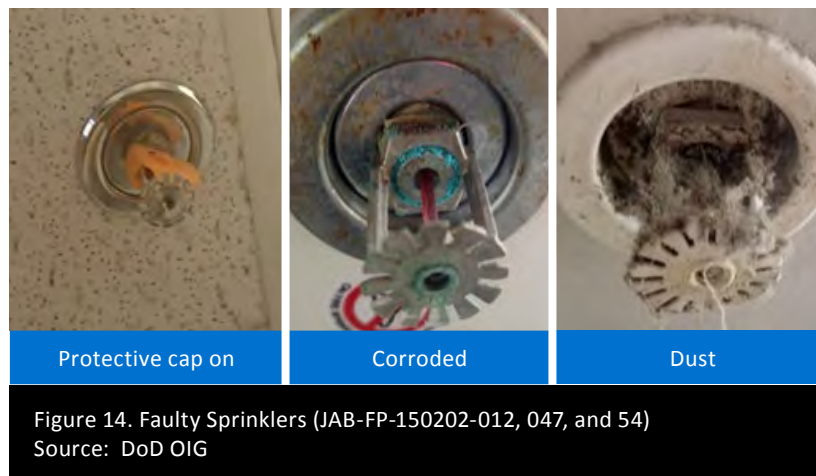
For fire suppression systems, we also found multiple instances of sprinkler heads throughout barrack and dormitories with protective caps still on, clogged with dust and/or debris, corroded, covered with paint, or missing escutcheons (see Figure 14). Painted or clogged sprinklers that are not installed and maintained properly can fail to operate, leading to a fire spread.

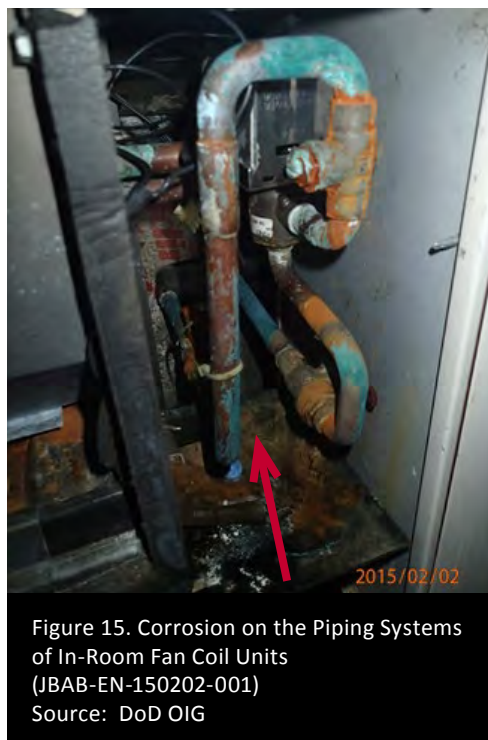
At Blanchard Hall rooms, we found evidence of insufficient ventilation and humidity control that impacted HVAC and fire suppression system metal components. There was significant corrosion on the piping systems of in-room fan coil units (see Figure 15). Although mold growth was not identified during the inspection, the evidence of uncontrolled moisture was a potential source for future mold growth. High humidity could cause amplification of fungal growth in the indoor environment that could lead to increased occupant exposure risk to airborne microbial materials.

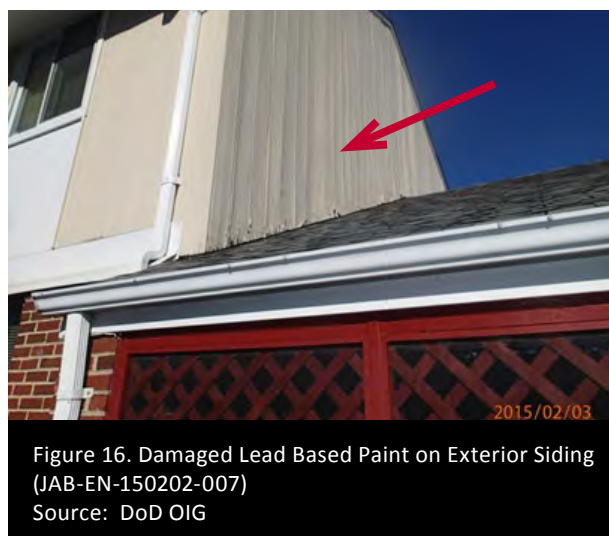
During the inspection of Westover Estates accompanied housing, we noted evidence of damaged lead based paint on exterior siding components (see Figure 16). The observed presence of damaged lead based paint confirms that lead hazards had not been addressed, as required by the Bolling Family Housing Asbestos-Containing Materials/Lead Based Paint/Hazardous Materials O&M Plan. The Bolling Family Housing O&M plan states that, “lead hazard may exist, if the Lead based paint is flaking, peeling, chalking, or otherwise defective,” and also states, “[l]ead hazards should be addressed.” Damaged lead based paint could increase the risk of occupant tenant exposure to lead compounds.
